CEB
CIVIL

Pre-Purchase Building & Timber Pest Inspection Report

In accordance with Australian Standard AS 4349.1 - 2007 and AS 4349.3-2010

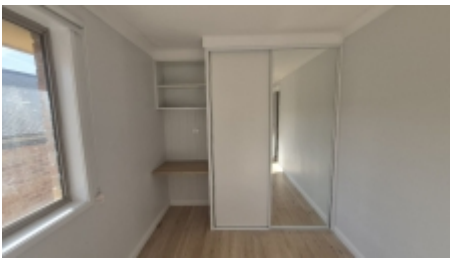
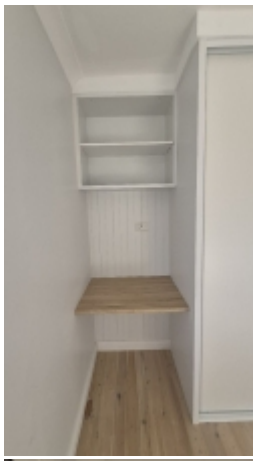
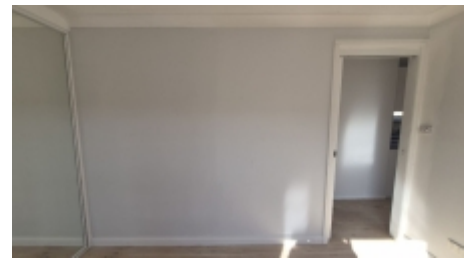
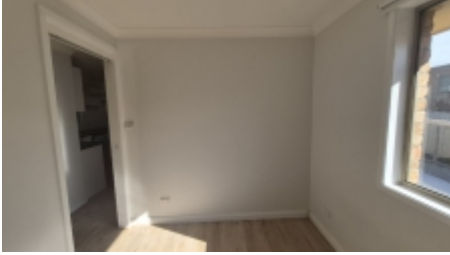
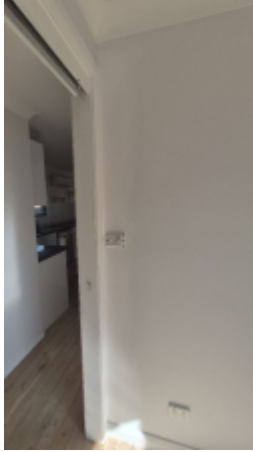
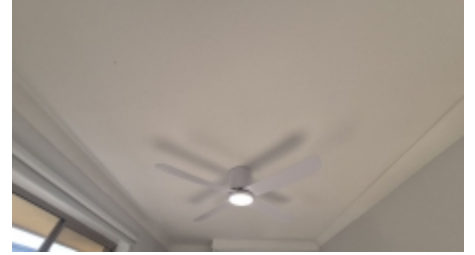
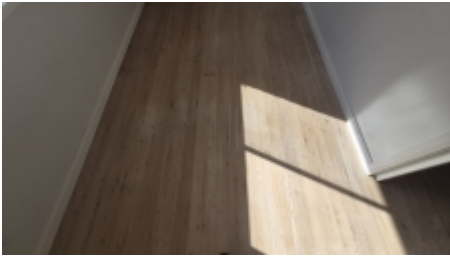
Defect Images

Defect Severity	Minor Defect
Defect Classification	F - Installations (including omissions)
Defective Item	Walls
Defect	Surface Defects
Comment	Inconsistencies in paint and finishes, signs of peeling or flaking, or surface damage.

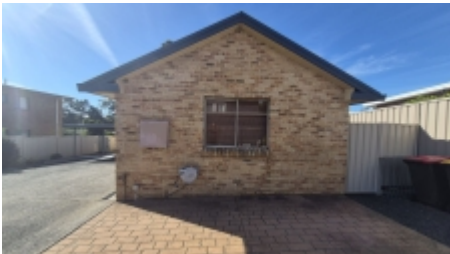
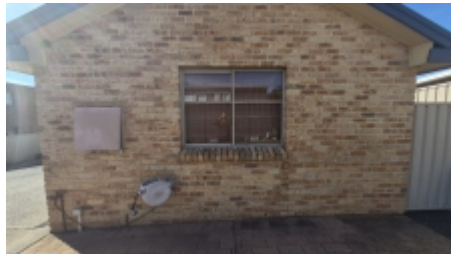
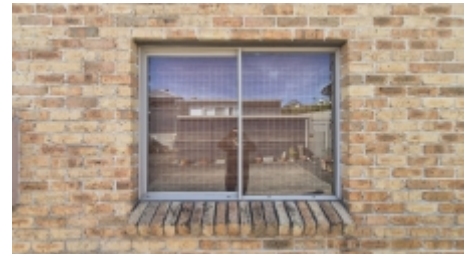
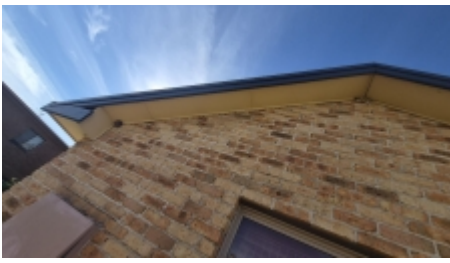
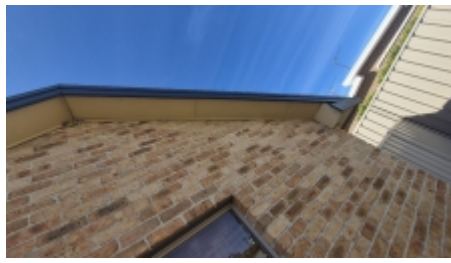
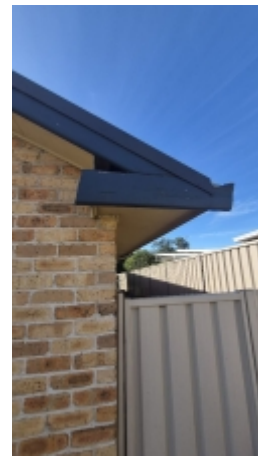
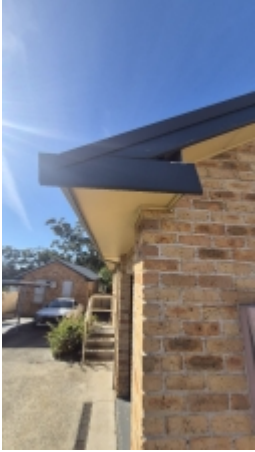
Front Elevation

Defective Item	Walls
Defect	Acceptable
Comment	Exterior walls are in good condition with no visible signs of cracks, damage, or significant wear. They are well-aligned and securely fixed.

Defective Item	Timber or Steel Frames
Defect	Acceptable
Comment	Frames are in good condition with no visible signs of cracks, damage, or significant wear. They are well-aligned and securely fixed.

Defective Item	Suspended Concrete Floors
Defect	Acceptable
Comment	Suspended concrete floors are in good condition with no visible signs of cracks, damage, or significant wear. They are well-aligned and securely fixed.

Exterior doors and windows are in good condition with no visible signs of cracks, damage, or significant wear. They are well-aligned and securely fixed.

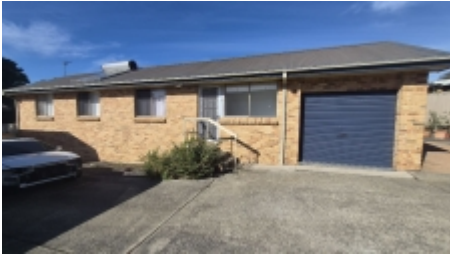
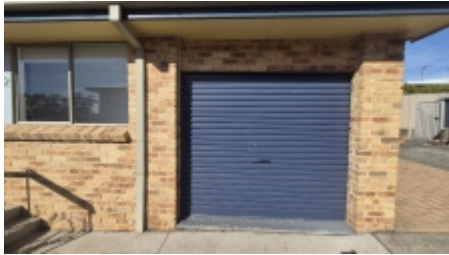
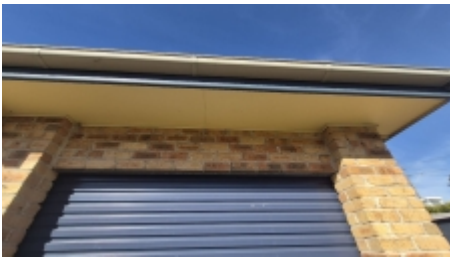
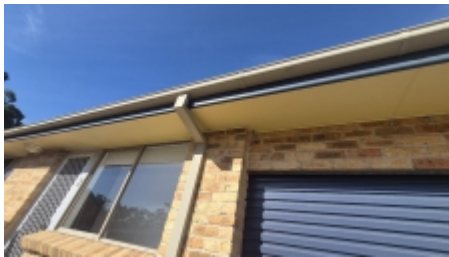
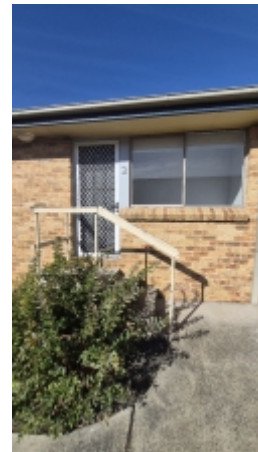
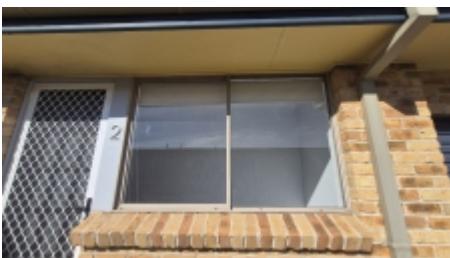
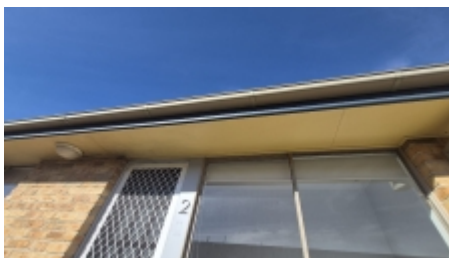
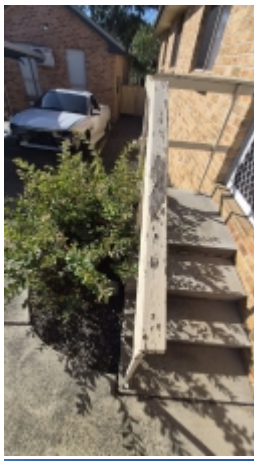
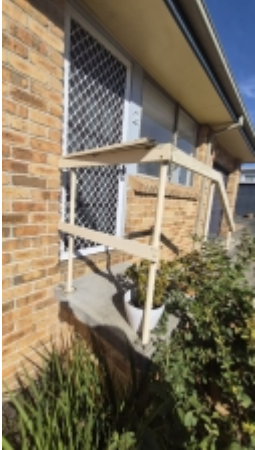
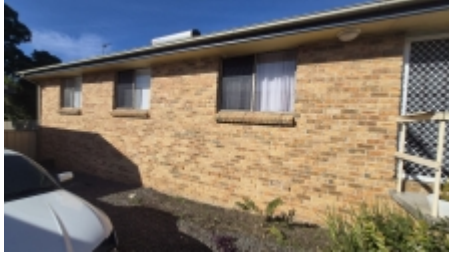
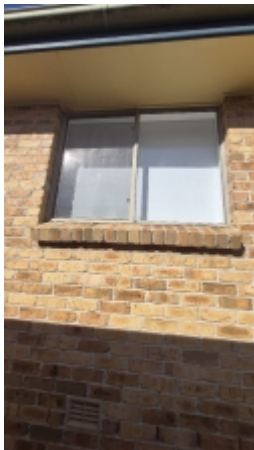
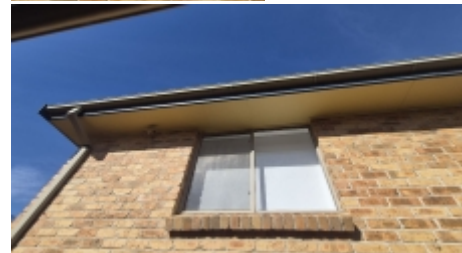
Right Side Elevation

Defect	Acceptable
Comment	Exterior walls are in good condition with no visible signs of cracks, damage, or significant wear. They are well-aligned and securely fixed.
Defect Images	
<hr/>	
Defective Item	Timber or Steel Frames
Defect	Acceptable

Comment	Frames are in good condition with no visible signs of cracks, damage, or significant wear. They are well-aligned and securely fixed.
Defect Images	
<hr/>	
Defective Item	Suspended Concrete Floors
Defect	Acceptable

Comment	Suspended concrete floors are in good condition with no visible signs of cracks, damage, or significant wear. They are well-aligned and securely fixed.
Defect Images	
<hr/>	
Defective Item	Stairs
Defect	Acceptable

Comment	External stairs are in good condition with no visible signs of cracks, damage, or significant wear. They are well-aligned and securely fixed.
Defect Images	
<hr/>	
Defective Item	Doors and Windows
Defect	Acceptable

Comment	Exterior doors and windows are in good condition with no visible signs of cracks, damage, or significant wear. They are well-aligned and securely fixed.
Defect Images	
<hr/>	
Defect Severity

Minor Defect
Defect Classification	C - Water Penetration, Damp Related
Defective Item	Balustrades
Defect	Cracks or Damage

Comment	Signs of cracks or damage observed in the balustrades, potentially affecting their structural integrity and overall performance.
Defect Images	
<hr/>

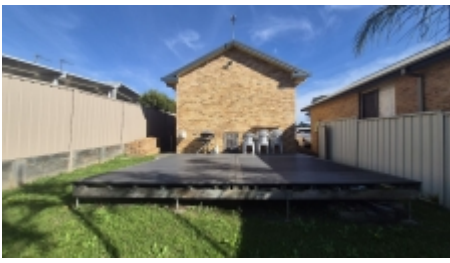
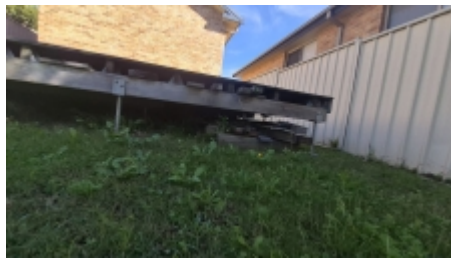
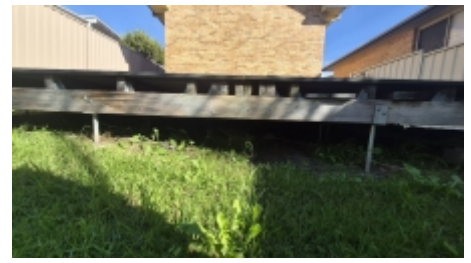
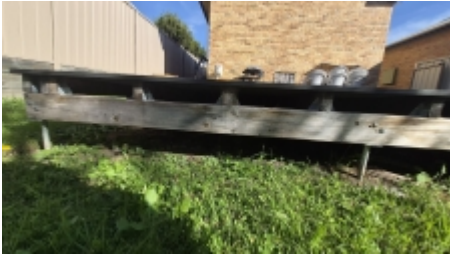
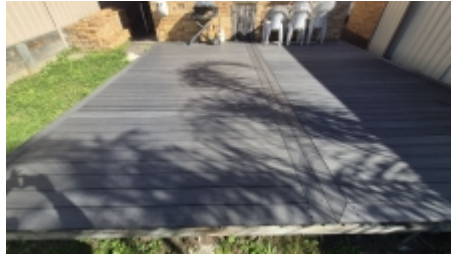
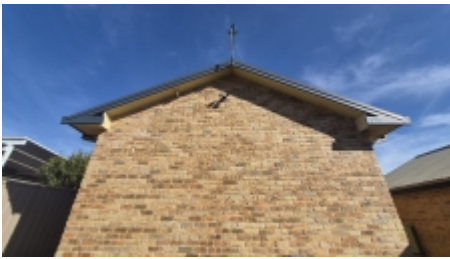
Rear Elevation

Defective Item	Walls
Defect	Acceptable
Comment	Exterior walls are in good condition with no visible signs of cracks, damage, or significant wear. They are well-aligned and securely fixed.

Defective Item	Timber or Steel Frames
Defect	Acceptable
Comment	Frames are in good condition with no visible signs of cracks, damage, or significant wear. They are well-aligned and securely fixed.

Defective Item	Patio/Decks
Defect	Acceptable
Comment	Patio/Decks are in good condition with no visible signs of cracks, damage, or significant wear. They are well-aligned and securely fixed.

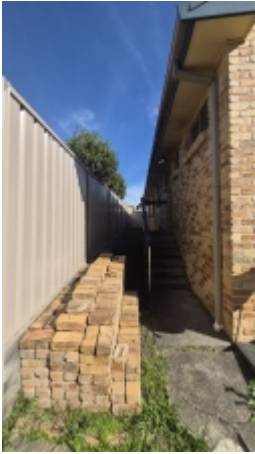
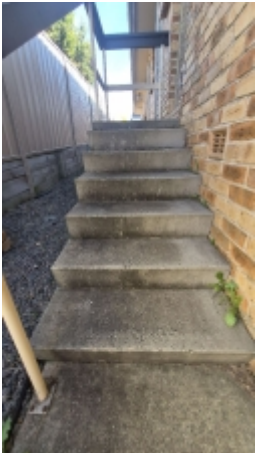
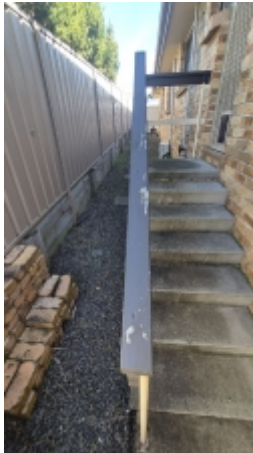
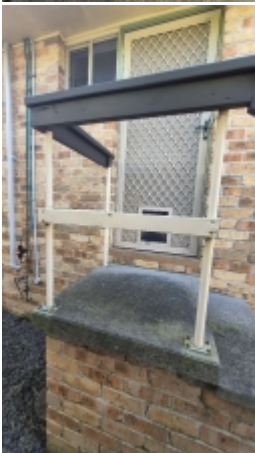
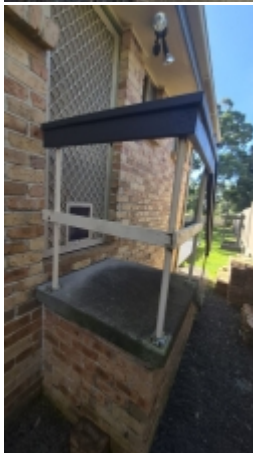
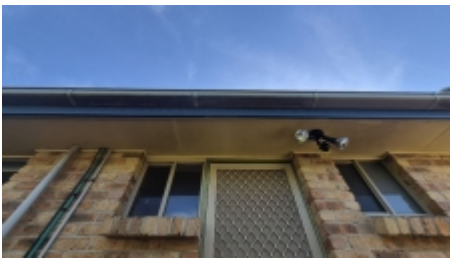
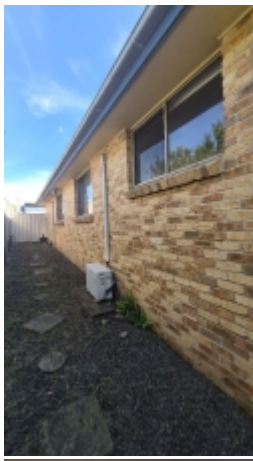
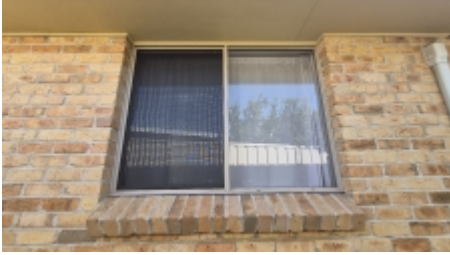
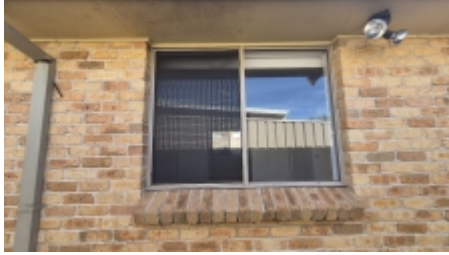
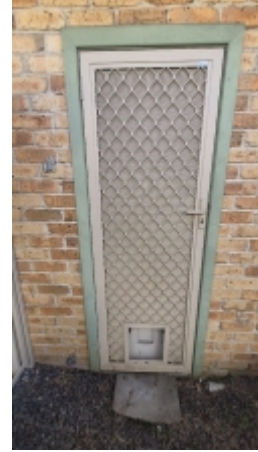
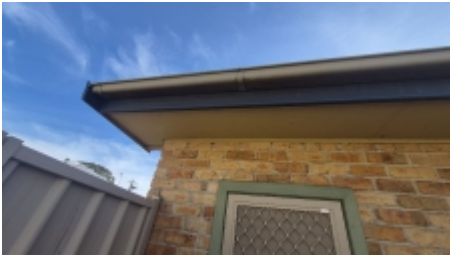
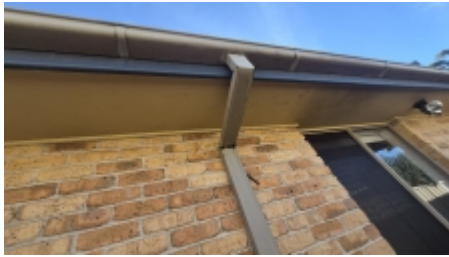
Left Side Elevation

Defective Item	Walls
Defect	Acceptable
Comment	Exterior walls are in good condition with no visible signs of cracks, damage, or significant wear. They are well-aligned and securely fixed.

Defective Item	Timber or Steel Frames
Defect	Acceptable
Comment	Frames are in good condition with no visible signs of cracks, damage, or significant wear. They are well-aligned and securely fixed.

Defective Item	Stairs
Defect	Acceptable
Comment	External stairs are in good condition with no visible signs of cracks, damage, or significant wear. They are well-aligned and securely fixed.

Defective Item	Doors and Windows
Defect	Acceptable
Comment	Exterior doors and windows are in good condition with no visible signs of cracks, damage, or significant wear. They are well-aligned and securely fixed.

Defect Severity	Minor Defect
Defect Classification	C - Water Penetration, Damp Related
Defective Item	Balustrades
Defect	Cracks or Damage
Comment	Signs of cracks or damage observed in the balustrades, potentially affecting their structural integrity and overall performance.

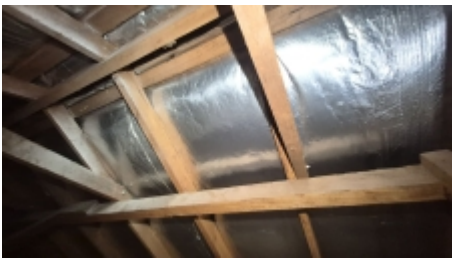
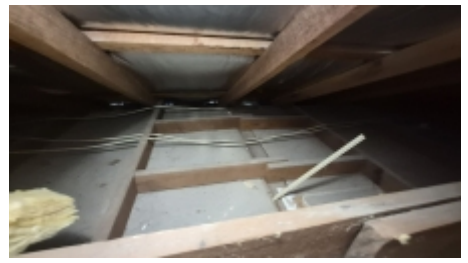
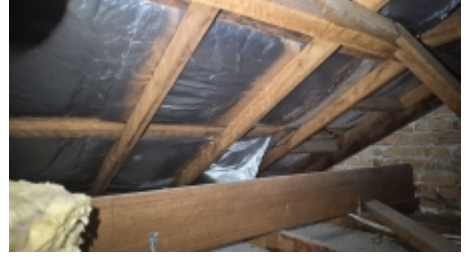
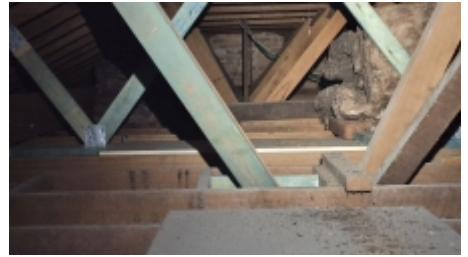
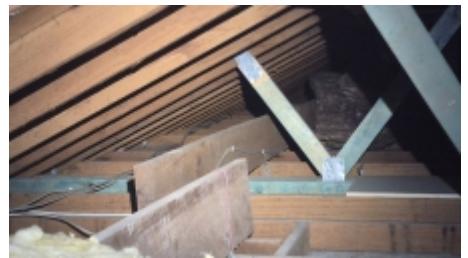
Roof Space

Defective Item	Insulation
Defect	Misalignment or Loose Fixings
Comment	Misalignment or loose fixings observed in the insulation, potentially affecting its functionality and the overall building performance.

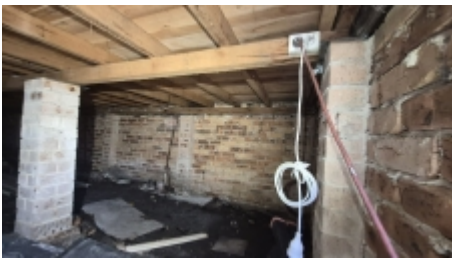
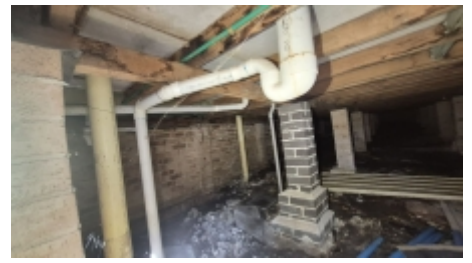
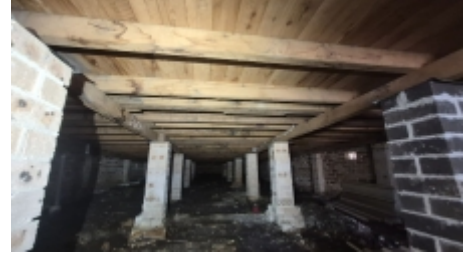
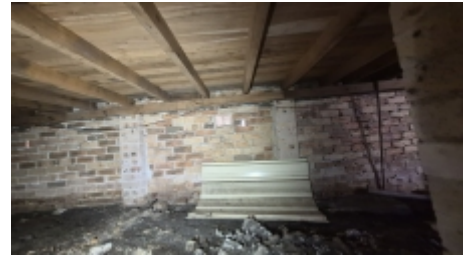
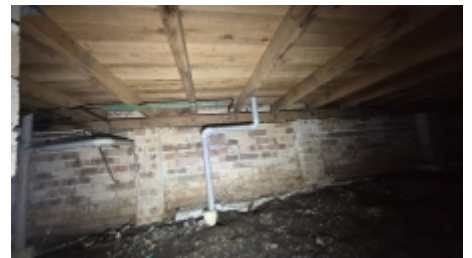
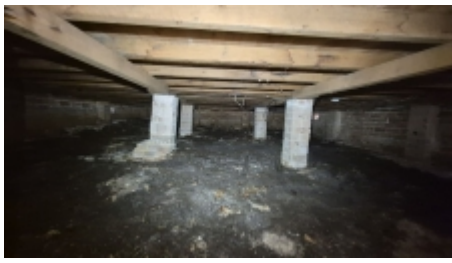
Subfloor Space

Defect Severity	Minor Defect
Defect Classification	B - Distortion, Warping, Twisting
Defective Item	Timber Floor Supports
Defect	Misalignment or Loose Fixings
Comment	Misalignment or loose fixings observed in one timber floor supports, potentially affecting the stability and levelness of the floor. To rectify this you will need to realign that one that as moved

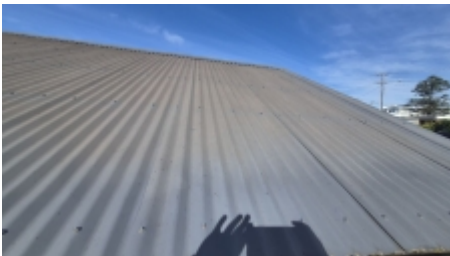
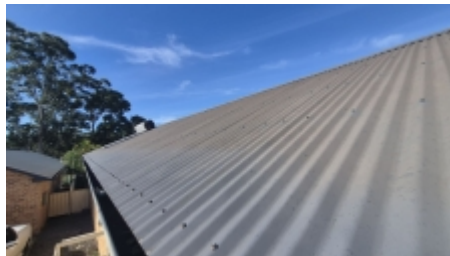
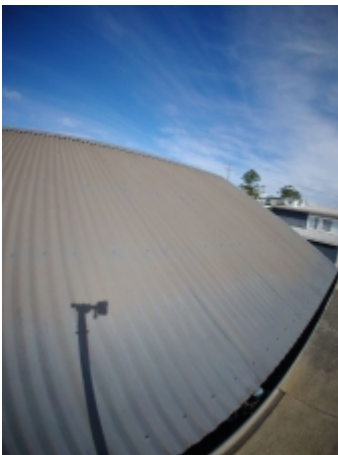
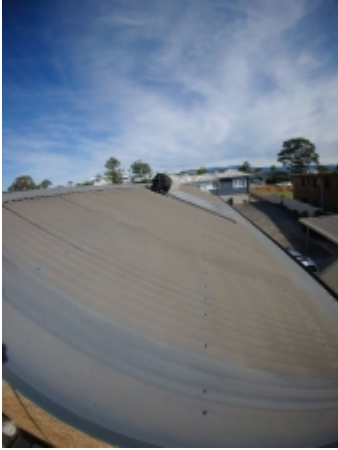
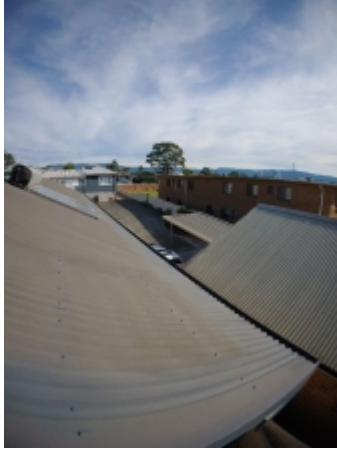
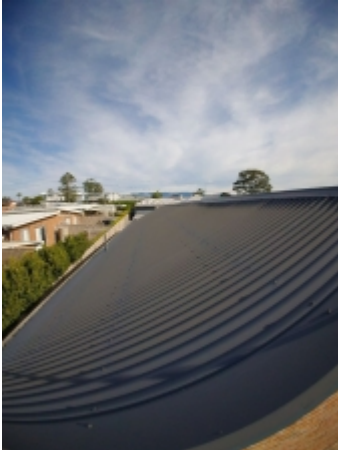
Roof Exterior

Defect Severity	Minor Defect
Defect Classification	C - Water Penetration, Damp Related
Defective Item	Fascias
Defect	Rot or Decay

Comment	Signs of rot or decay observed in the fascias, potentially affecting their stability and overall roof performance.
---------	--
